Re – Setting of Pit Wheel

at

Eling Tide Mill

Winter 2022/2023

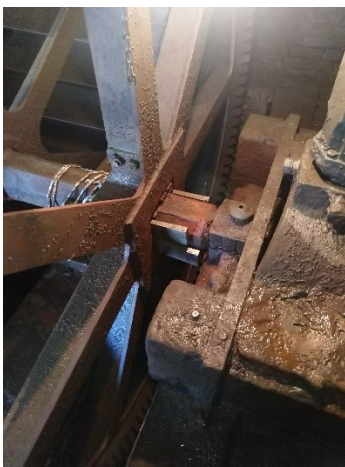
Figure 1 Work Under way

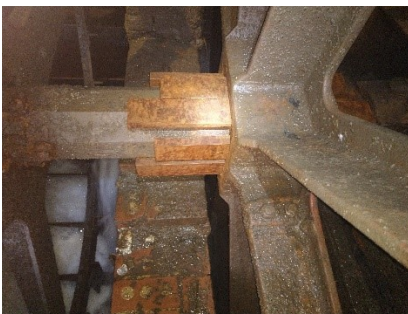
Figure 2 Job Completed. Wedges left log pending future repair work to adjacent structure
