New Bulkhead for an Old Mill

Van Wyck-Lefferts Tide Mill Sanctuary, Inc.

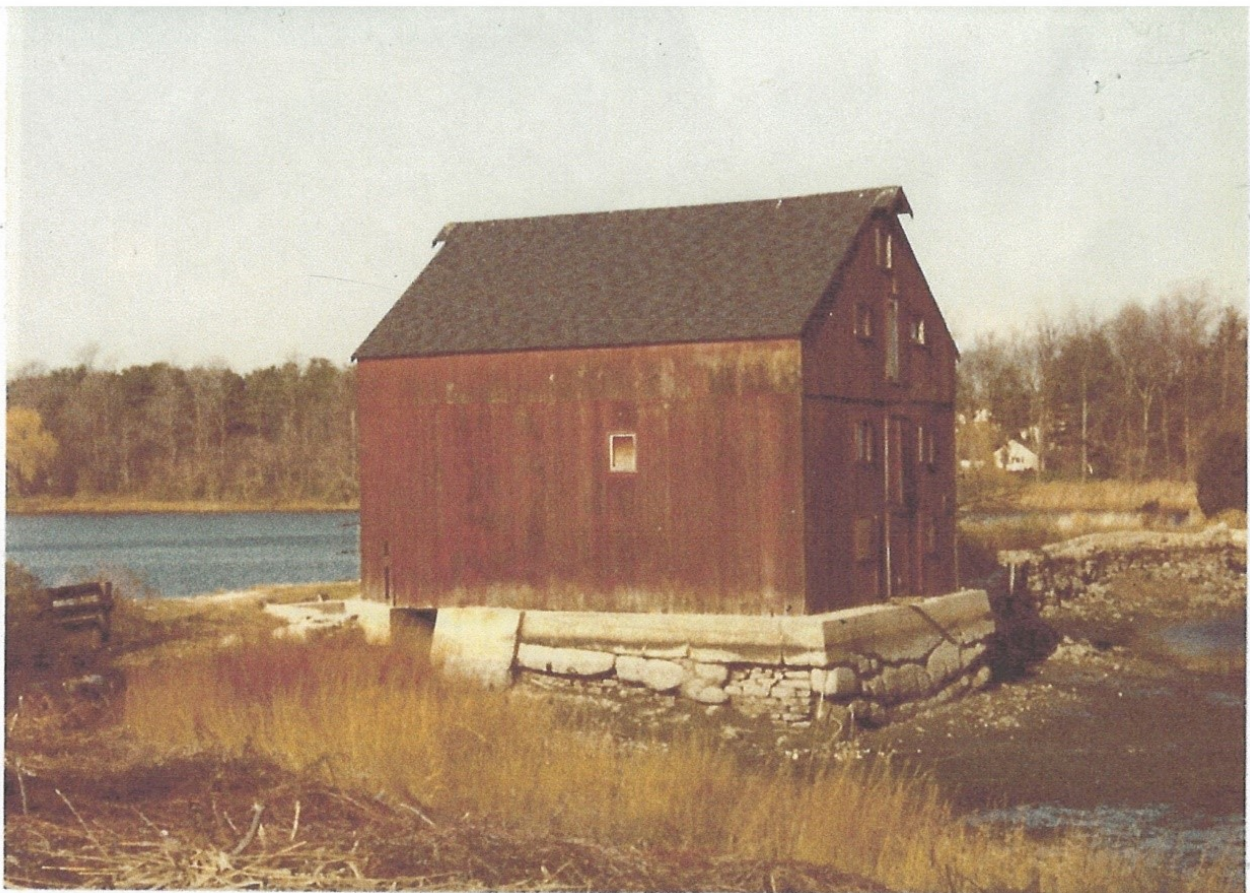
A large section of concrete was left in place, at the opening through the foundation where the water wheel used to be, at the southwest corner of the mill. This concrete was in good condition at the time, and was securely encased around the exterior and interior of the foundation. It was felt that this concrete was providing effective protection of the foundation, and that removing the concrete could destabilize the stone foundation. Also, the cost of this removal, and subsequent additional bulkheading, was not in the allotted budget.

Deteriorated concrete encasement - 1983

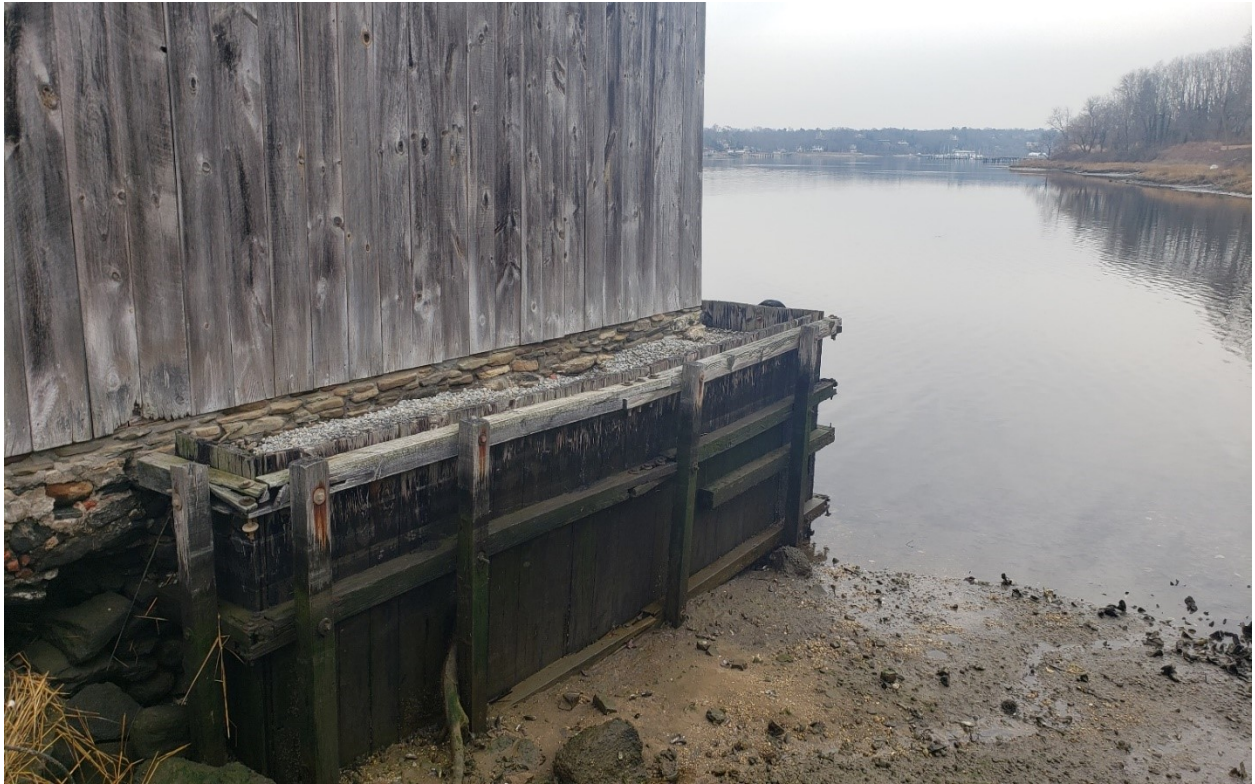
Based upon an engineering inspection performed in February 2020, the bulkhead has performed well, providing effective protection of the foundation from ice and tidal damage. Comparison of photos from 1984 and 2020 show little change to the repaired stone foundation. However, the bulkhead is in poor condition. The life expectancy of a timber bulkhead is in the range of 35-45 years, depending upon its environmental exposure. The bulkhead is approaching the 40-year mark and it is seriously deteriorated. The timbers are rotted, and bolts are rusted.

South facing bulkhead – 2020

The engineering assessment of 2020 determined that the bulkhead structure should be retained as a permanent barrier to provide protection of the foundation into the future, as it had provided good protection since it had been installed. It was recommended that the bulkhead be replaced as soon as funds were available. Plans were drawn up for the new bulkhead. It was determined that removal of the existing bulkhead would allow the crushed stone fill to spill out onto the harbor bottom, as there is no way to adequately remove the crushed stone without damaging the bulkhead. This was detrimental to the site and ran counter to NYSDEC protocols. It was decided to keep the existing bulkhead and install the new bulkhead directly in front of the existing. The new bulkhead will, again, be a timber structure, as it fits the aesthetics of the site and mill structure. A steel sheet bulkhead was considered, which would have a life expectancy of about 80 years. However, the NYSDEC was not amenable to that proposal. Besides, the look of the steel would be very industrial, which would be out-of-place in that setting.

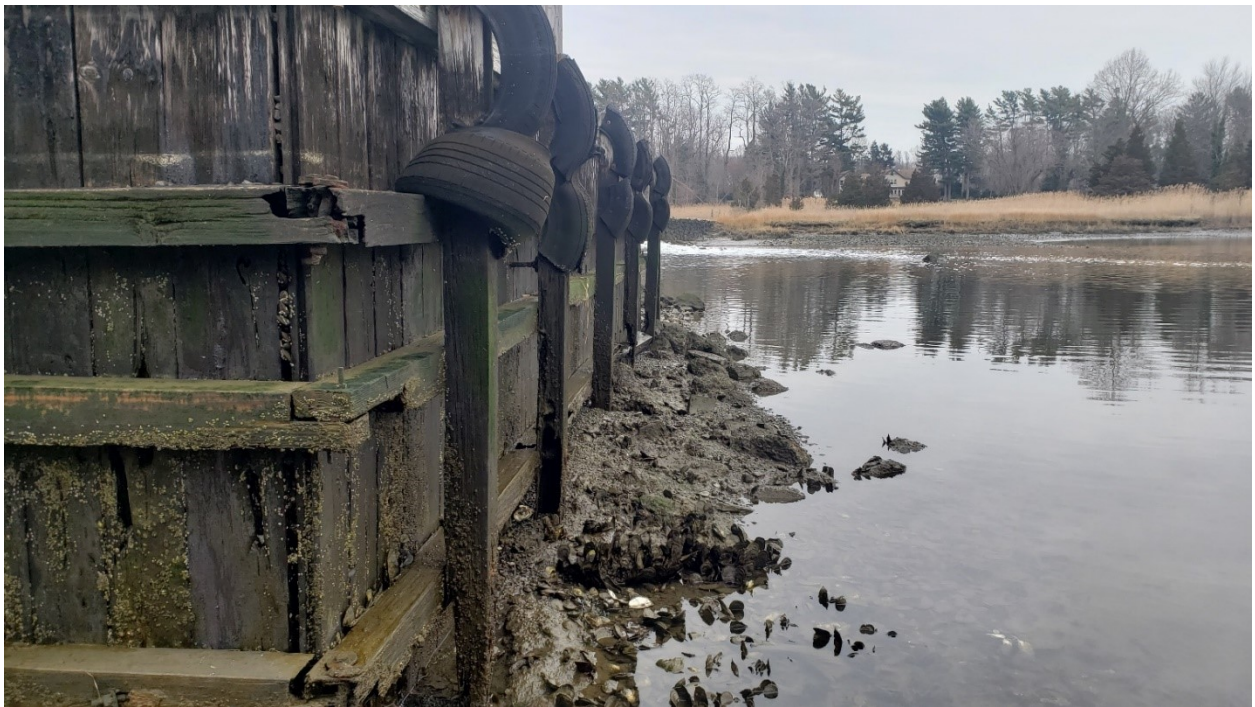
East-facing bulkhead - 2020
